EFFECT OF OPEN DUMPSITE ON UNDERGROUND WATER QUALITY IN GANMO, KWARA STATE

Agboola, R. O., Sunmonu, L. A. and Suleman, K. O. (2021). Effect of Open Dumpsite on Underground Water Quality in Ganmo, Kwara State. *The Nexus (Science Edition)*. 1(1): 17 - 23

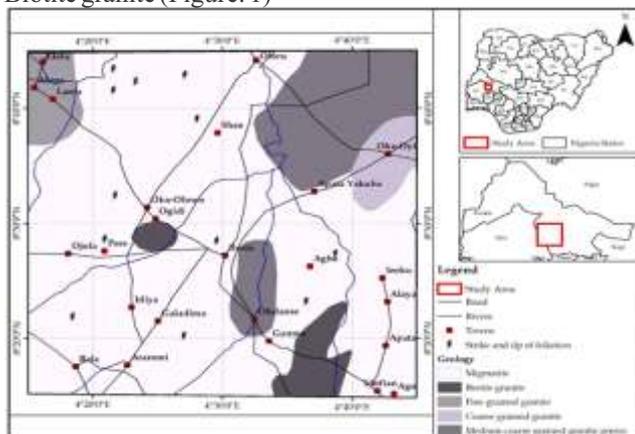
Figure1: Geological Map of Study Area Showing Investigated Site

Ganmo is one of the districts in Ifelodun Local government Area in Kwara State, bounded by latitude 8°15' and 8° 20'N and longitude 4° 40'E. The Weather condition in the region is of two broad types (i.e. rain season and dry season). The rain season commences around March and ends in October, while dry season begins in November and ends in March. The annual rainfall ranges from 75 to 112 mm. The humidity ranges between 60 to 89% and mean annual temperature is between 27 to 30° (Suleet *et al.*, 2013). It falls in the basement complex of south western part of Nigeria, which is of Precambrian to lower Paleozoic in age (Oyawoye, 1972; Rahaman, 1976; Oluyide, 1979). This Precambrian crystalline basement complex consists of Migmatite and Biotite granite (Figure. 1)

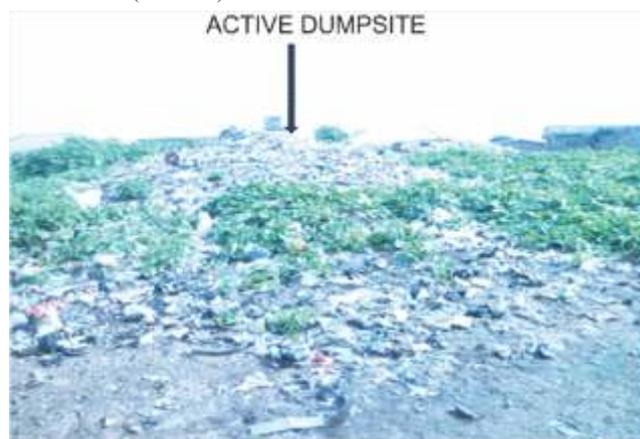
Plates 1: Open Dumpsite, Ganmo, Ifelodun

The hydrological setting of the area is typical of what is obtainable in other basement complex area, where the availability of water is a function of the presence of thick-little clay overburden material and presence of water filled joints, fracture or faults within the fresh basement rocks. The humid tropical climate of Ilorin has particularly encouraged relatively deep weathering of the near surface rocks to produce porous and permeable material that allows groundwater accumulation as shallow aquifer which is recharged principally through infiltration of rainwater (Ige, 2014). The study area is located behind the Ganmo main market along Ajase-Ipo road from Ilorin metropolis. It is the most active dumpsite in the area because of its closeness to the Market (Plate. 1)

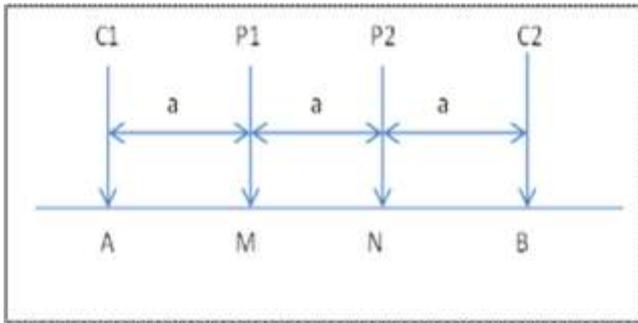
Figure 2: Conventional electrode array for electrical resistivity method (Wenner alpha array)

The electrical resistivity techniques adopted were Vertical Electrical Sounding (VES) and 2-D Electrical Resistivity Profiling. The resistivity profiling was adopted to map out lateral variations in subsurface resistivity that exist in the survey area along the traverses. The Vertical Electrical sounding was used to characterize the various lithological units and to determine the depth to water table. In Electrical Resistivity Profiling and Vertical Electrical Sounding (VES) measurement, electric current (I) was introduced into the ground through a pair of electrodes A (C1) and B (C2), while electrodes M (P1) and N (P2) measured the potential difference (ΔV) (Figures. 2& 3). Profiles were established on the dumpsites and outside the dumpsites area as control at the extent of 100m away. This operation was repeated when the distance between current electrodes were increased, together with an increase of the study depth. Values of apparent resistivity (ρ_a) were calculated in each distance AB using equation:

$$\rho_a = (\Delta V/I)G \quad (I)$$

(Where $G = \rho \left(\frac{AB}{2}\right)^2 / MN$ is geometrical factor which is determined by the electrode configuration of the array.)

Wenner alpha array (Figure 2) was employed to acquire the Resistivity, using Direct Data Capture (DDC-8) resistivity meter. The field data were interpreted by applying RES2DINV software. Schlumberger electrode configuration (Figure.3) was also employed to acquire Vertical Electrical Soundings (VES) with maximum half current electrode spacing ($AB/2$), using Direct Data Capture(DDC-8) resistivity meter. In this method, the centre point of the electrode array remains fixed, but the spacing between the electrodes is increased to obtain more information about the deeper sections of the subsurface. Three vertical electrical soundings (VES) were conducted at preferred points in the study area. Values of apparent resistivity (ρ_a) recorded were interpreted by applying WINRESIST modeling software while 1-D electrical resistivity tomograms were generated.

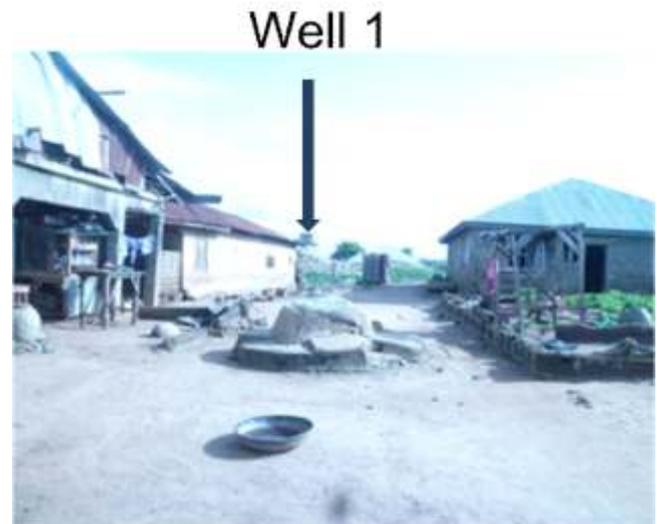
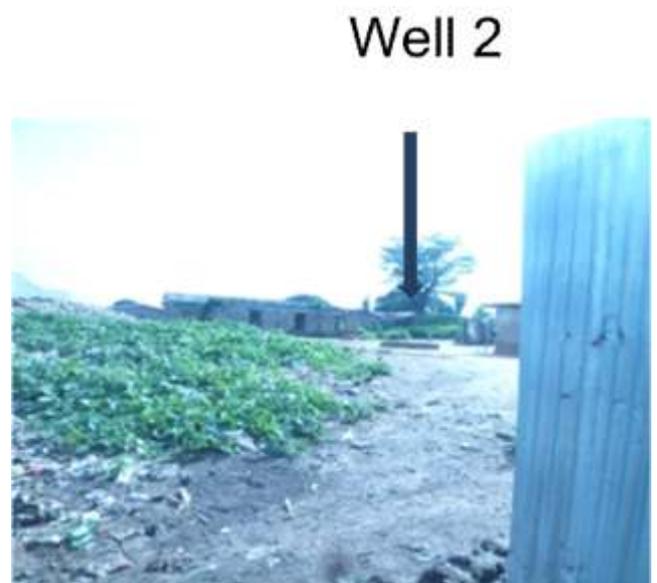
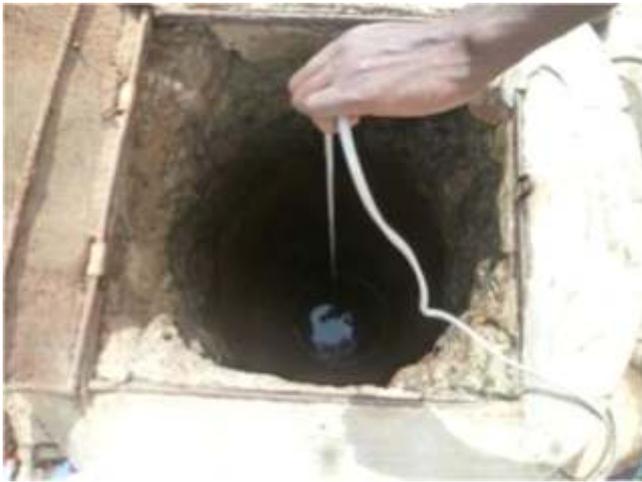
Plate 2: (a & b) Nearby hand dug wells (c) Water Sample Collection

Water samples were taken early in the morning from the three available wells (Plates 2:a-c) around the dumpsite in cleaned plastic polyethylene bottles and brought to the laboratory in an icebox jar to avoid unusual change in water quality. Prior to the sampling, all the bottles were washed and rinsed thoroughly with distilled water. Standard methods were followed for sample collection and preservation. Field measurements include physicochemical parameters such as temperature, pH and other physical parameters including: water level, depth to bottom of the well, total dissolved solids, colour, odour, taste, and turbidity. Global Positioning System was used to perform geo-referencing of each sampling point. Cation sampling solutions were acidified (HNO_3) to prevent metallic ions from adhering to the walls of the

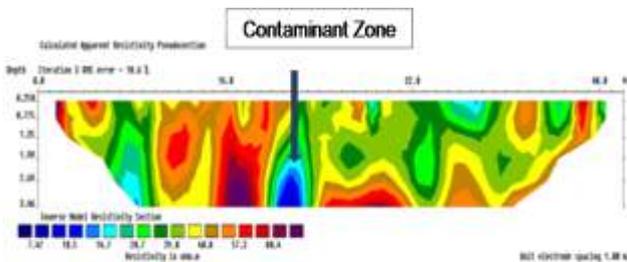
Figure 4: The apparent resistivity pseudo-sections from 2-D imaging survey

Figures (4 and 5) are the apparent resistivity pseudo-sections from 2-D imaging survey of the study area and the control, showing different colour description in terms of resistivity values upon which the results were interpreted. The blue colour depicts low resistivity zones, the brown colour shows the high resistivity zones, while other colours were within the range.

The Results of the study area as presented in figure 4 showed a contaminant leachate plume delineated in 2-D resistivity sections as low resistivity zones. The 2-D resistivity imaging showed bluish zones of low resistivity range of 7.47 to 10.50 Ω m with the depth range of 2.69 to 3.46 m in the entire inverse model sections. The low resistivity value obtained revealed the portion of dumpsite that the contaminant was situated. Comparing the profile within the dumpsite to profile 60m away outside the dumpsite serving as control (Figure.5), it was noted, generally, that rocks outside the dumpsite are more resistive than those within the dumpsite indicating non pollutant. The Structures suggesting local pool of contaminant on the dumpsites as shown on 2-D ERP tomograms. High resistivity signatures on 2-D ERP tomograms suggest the presence of basement rocks that are not permeable to contaminant infiltration.

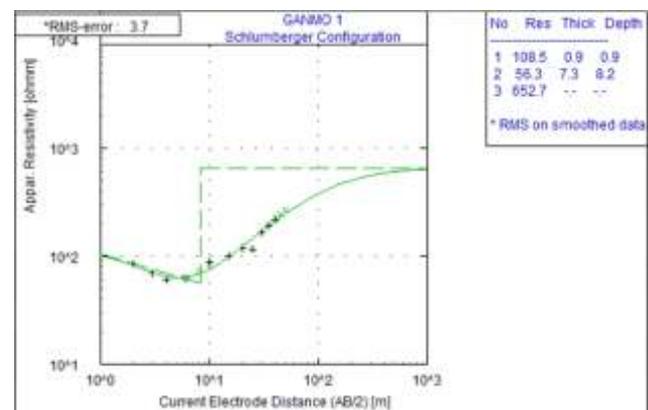
(a) H-Type Curve for VES-1

Figures 6 (a)–(c) are VES Type curves obtained in the study area. Various important point along the curve indicate: resistivity, thickness, depth and layers of the area

The VES data interpretation results are presented in Figures 6(a)-(c). The partial curve matching technique carried out on the field data acquired on the dumpsite and control revealed a 3 layered model (Ige, 2014) with H and A type curve ($\rho_1 > \rho_2 < \rho_3$, $\rho_1 < \rho_2 < \rho_3$) for all the soundings. The VES interpretation reveals three geo-electric layers across the research area: the topsoil consisting of sand and decomposed organic matters; the weathered layer and the bedrock constituting the fractured or fresh basement. The geo-electric sections show subsurface variation in electrical resistivity along the profiles, as presented in Table 1. However, the low
