AEROMAGNETIC AND RESISTIVITY TOMOGRAPHY TECHNIQUE FOR INVESTIGATING LEAKAGE PATHS IN APODU DAM, ILORIN SHEET 201, SOUTHWESTERN NIGERIA

Keywords: Aeromagnetic, Resistivity tomography, Geologic structure, Dam Seepage

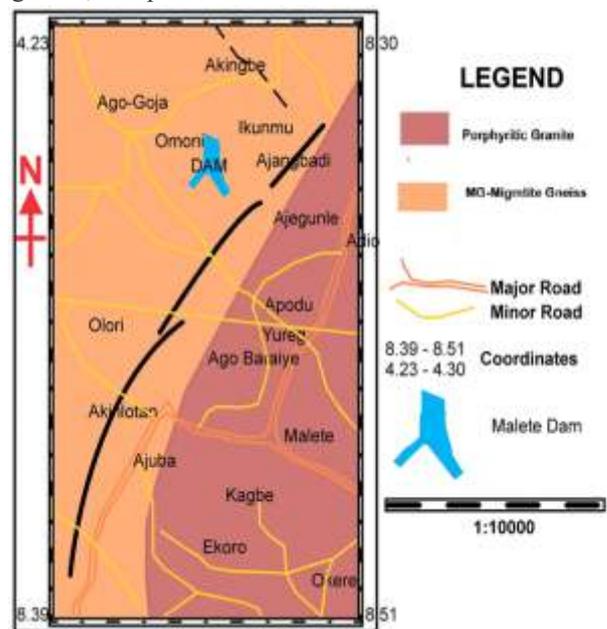
Fig 2: Updated Geological map of Apodu dam area (Modified after NGSA, 2017)

Lithologies identified from the geologic map of the study area (Figure 2) include; migmatite-gneiss, porphyritic-granite, and quartz veins.

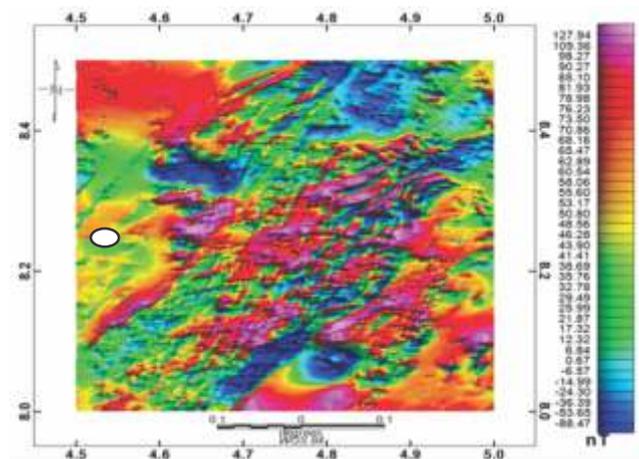
Figure 3: Residual Magnetic Intensity map of sheet 223 (Apodu dam area).

The residual magnetic intensity map of Apodu dam (Figure 3) shows that the magnetic intensity values ranged from high (127.94 nT) to low (-88.47 nT). Negative anomalies were observed in the area which may be due to the presence of low magnetic rocks (e.g. shale, sandstone, limestone) in the area, that are noted for low magnetic signatures. Removal of the regional magnetic anomaly from the measured anomaly for sheet 223 also gives negative RMI values like that of sheet 202

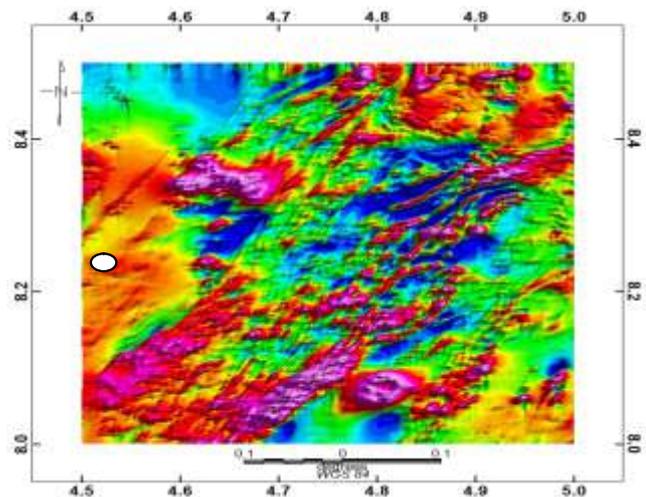
Figure 4: Reduced to pole map of sheet 223 (Apodu dam area)

Figure 4 shows the RTP map of the Apodu dam area. The RTP map depicts frequency variations present in the magnetized rocks of the area. The RTP places anomalies from the residual magnetic field directly over the magnetic field resulting from causative rocks producing these anomalies. The areas that were displayed as high and low magnetic anomaly zones in RMI maps are now shown as low and high magnetic anomaly zones respectively. Further, contacts between the low and high magnetic susceptible zones have also been enhanced. Various structures such as folds, faults, and rock lithology contacts have also been enhanced. Most of the low magnetic signatures emanate from rocks that have fewer magnetic minerals in them, while high signatures are being produced by rocks that have high magnetic minerals in them. The area of study falls within the basement complex of Nigeria, the basement complex is characterized by rocks of various ages and compositions. The area contains rocks such as migmatite, gneiss, granite, granodiorite, and schist. Most of the low magnetic anomalies come from the meta-sediments while high magnetic susceptibilities are from the competent basement rocks. The patterns that were observed on the RTP map are due to rock deformation especially at the central part of both sheets. The basement rocks have been folded during several phases of deformation and these had allowed the magnetic minerals that are present in such rocks to also reshape themselves in the manner that the host rocks have done. The northwestern part of the RTP map (Figure 4) shows low to moderate magnetic signature variation and has limited structures when compared to the rest of the area. The orientation in the two maps is the NE-SW direction which correlates the structural trends that were measured during the geological field mapping undertaken and have been reported by various authors on the basement complex of Nigeria.

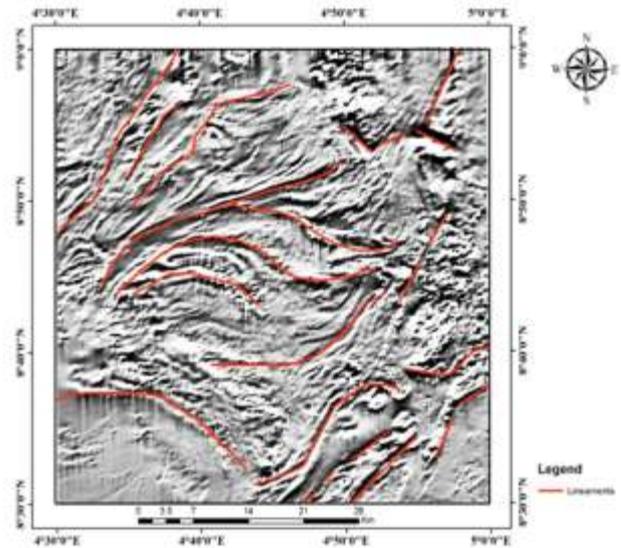
Figure 5: First Vertical Derivative (FVD) map showing lineaments in Apodu dam area

Figure 5 shows the first vertical derivative map of the area of study. The FVD grid was upwardly continued to a hundred meters to subvert the effects of deep source magnetic features and enhance shallow source magnetic features that are associated with geological structures. The red lines in figure 5 represents lineaments which are structural deformations that are related to geological features and arched zones or even geological contacts. Magnetic minerals are mainly concentrated along or aligned with some structures and lineaments were delineated by observing the abrupt change between the positive and negative magnetic anomalies. This gives a rough idea of the structure and lithologic deformations in the study area.

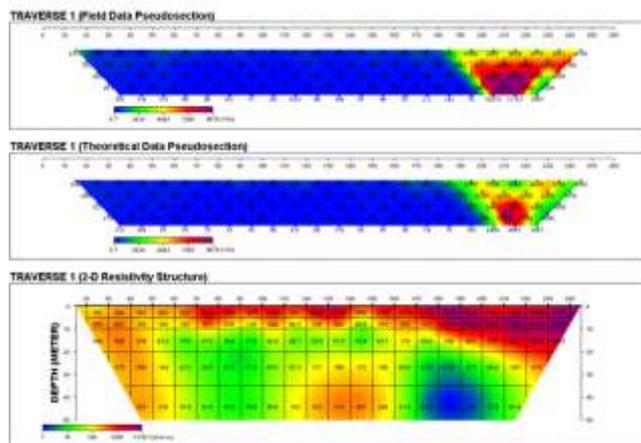
Figure 6: Interpretation of the geoelectrical section of the RTM 1 profile carried out in the upstream/centre of Apoduearthdam embankment

Figures 6 and 7 shows traverse 1 and traverse 2 pseudo-section of Apodu dam established along the dam embankment. It shows both the theoretical, field sections, and resistivity structures. It further shows the cross-section of points RTM 1 and RTM 2 profile of the subsurface up to a depth of 50 m. RTM 1 is along the upstream/center of the dam embankment while RTM 2 is along with the downstream of the dam embankment. The 2-D resistivity image shows three major resistivity zones; very low resistivity indicated by the blue coloration (depicting overburden and/or seepage zones or water-bearing soils), medium-range resistivity indicated by the green to yellow coloration (depicting lateritic soils, weathered basements, and indurated soils that is relatively impermeable to water), and the high range resistivity indicated by orange to purple coloration (depicting the fresh basement highly competent rocks).

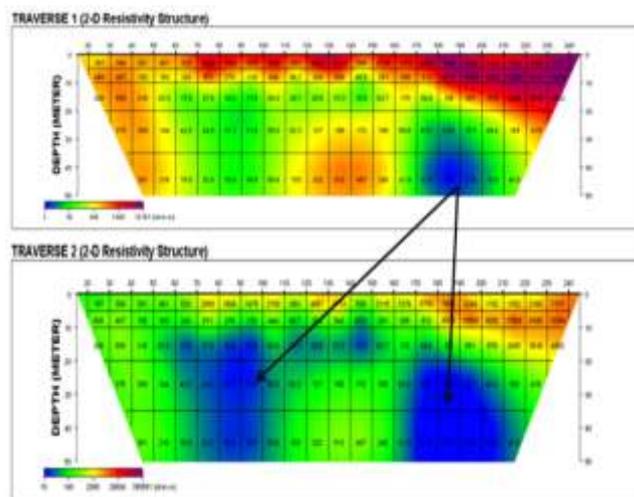
Figure 8: Correlation of RTM1 and RTM2 of Apoduearthdam embankment

Figure 8 correlates the resistivity of RTM1 and RTM2 of Malete earth embankment. The dam is well compacted at the surface which shows high resistivity values from the surface to about 8m below the surface. RTM1 shows a drop in resistivity values around A, indicating a weakness zone below a depth of 25 m at chainage 170 to 190. RTM2 indicated low resistivity values below 8 m as indicated with B and C, this is observed around chainage 55 to 150 m for zone B and chainage 165 to 218 m. The observed low resistivity indicates a weakness zone that is water-bearing and can be connected in RTM1 and RTM2, suggesting a possible pathway for water. This water pipe way is indicative of a possible seepage zone and adequate measures are expected to be made to arrest the situation.

Characterization of the Apodu dam subsurface for seepage appraisal using electrical resistivity tomography technique on the other hand revealed that the dam is well compacted at the surface but there are observed low resistivity values indicative of possible occurrences of weakness zones that are water-bearing in some areas of the dam embarkment body at depths of around 8m and 25m. The observed low resistivity indicates a weakness zone that is water-bearing and can be connected in RTM1 and RTM2, suggesting a possible pathway for water. This water pipe way is indicative of a possible seepage zone and adequate measures are expected to be made to arrest the situation.

Conclusively, Apodu dam is situated in a geologically stable environment as deduced from the aeromagnetic study but its earth embarkment is suspected to possess areas with possible seepages zones as obtained from the electrical resistivity techniques of investigations. There is therefore a need to quickly remedy the dam earth embankment to ensure the longevity of the dam and avert its eventual collapse.
